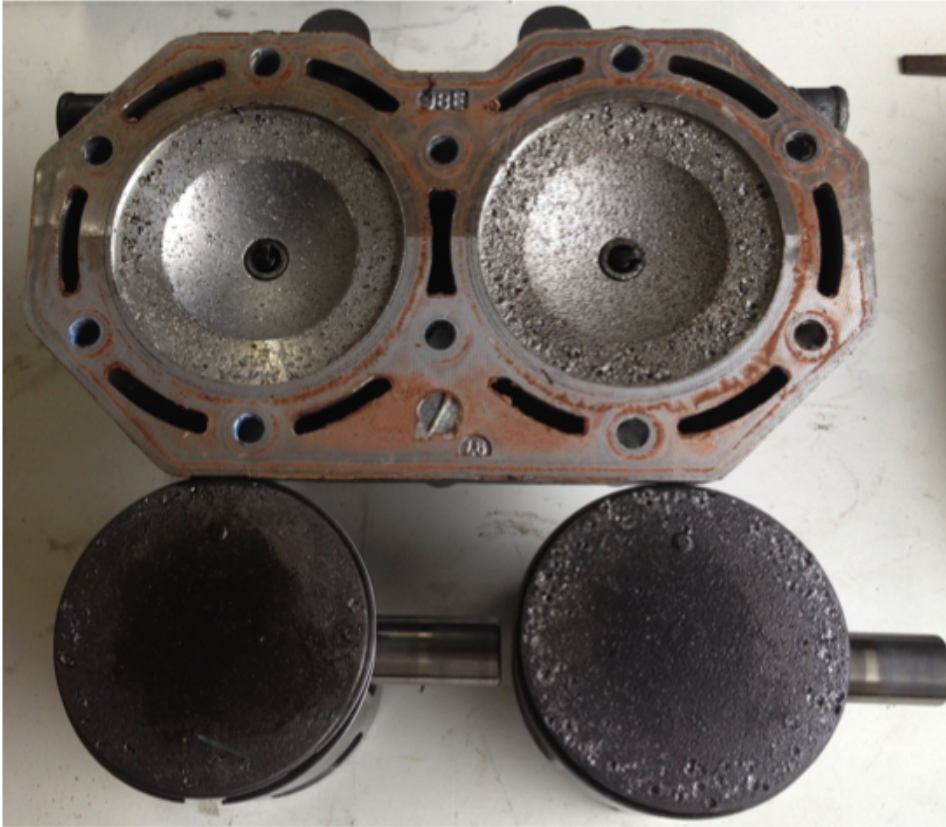
Photo #1

The engine now out of warranty I began to investigate back in my shop. I discovered a damaged MAG side spark plug. Removing the head revealed significant damage to the MAG side piston, head and plug. Damage of similar pattern but much less severe in the PTO side cylinder.

Close inspection of the damage suggests that something odd shaped was ingested. Other dents suggest something round and hard, like a bearing needle was ingested. I was however puzzled how this would damage both cylinders.

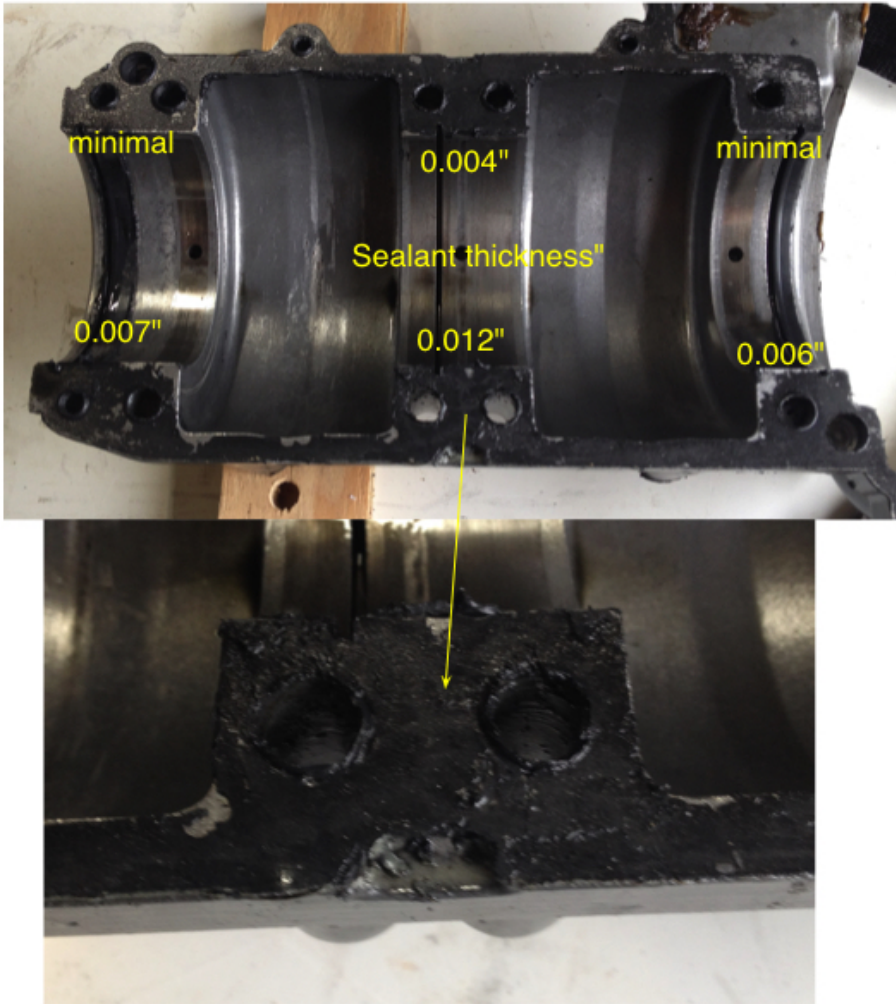
Photo #2

The first notable issue is the huge amount of sealant between the crankcase halves. The Tigershark service manual states, "**Apply a LIGHT COAT of Artic-Cat High-Temp Sealant to the bottom crankcase half.**" As the halves are assembled and torqued properly almost all of this LIGHT COAT should be squished out, remaining in minute imperfections, creating a tight, dimensionally accurate crankcase. The sealant remaining in the seam on this engine is totally unacceptable. One has to question how could this much REMAIN between properly torqued case halves. The sealant at the center bearing is 0.012" thick. Tapering to 0.007" at the PTO end and to 0.006 at the MAG end.

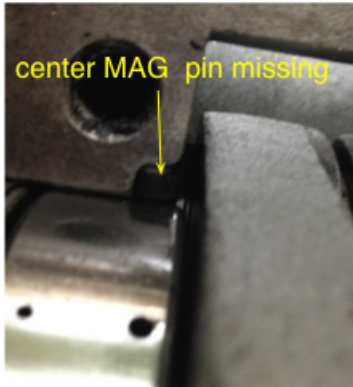
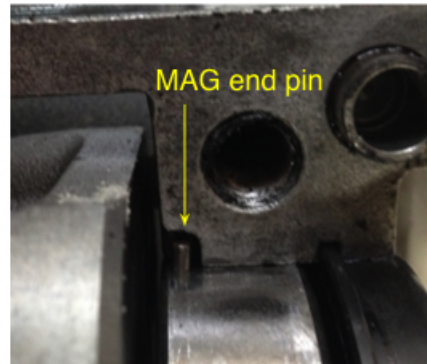
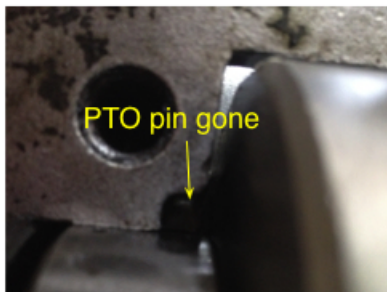
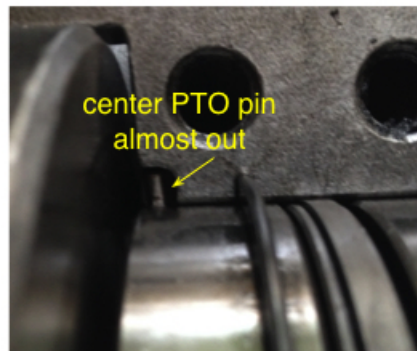
Photo #3

Further inspection revealed the cause of the cylinder/piston/head damage. There are 4 locating pins, one in each bearing. These pins keep the steel bearing race from rotating in the aluminum case. TWO of these pins are missing. One of the two remaining pins was almost out of the hole that is supposed to hold it in place.

Further inspection shows damage to the crankcase where these pins fell out and were dragged between crankcase and the crankshaft, gouging aluminum from the case.

This explains both kinds of piston/head damage. The pins caused the perfectly round dents. The aluminum gouged from the crankcase explains the randomly shaped damage. I have to assume the PTO pin was the first to come out as the crankcase damage is more severe and there is much less piston damage. It appears this pin stalled the engine when the crank caught it. On restart, the pin went through the cylinder quickly and did not damage the spark plug. This also explains why the engine was reluctant to turn over when I first tried to restart. The MAG side pin came out next. Running at higher speed it went quickly through the crankcase, but stayed in the cylinder longer, damaging the plug.

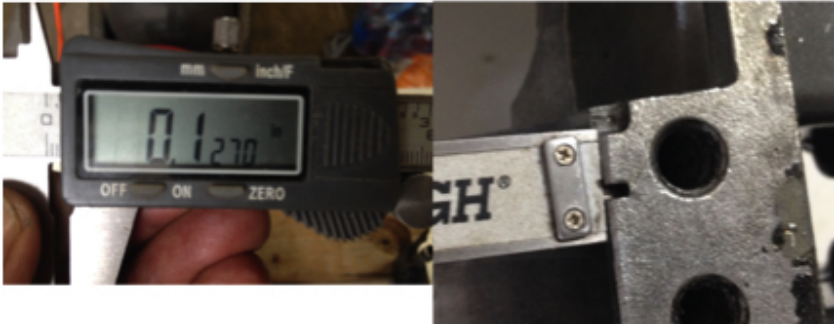
Photo #5

1) The center bearing on the PTO side is the thrust bearing for this engine. A groove in the bearing matches a groove in the crankcase. The Service Manual states; ***“Install the C-ring ... into the upper crankcase half”***. The bearing on the engine SBT assembled has a full ring on the bearing. This might have been an acceptable change, perhaps even an improvement over the C-ring. HOWEVER, the ring they installed stands from 0.130” to 0.137” above the bearing. The groove it is intended to fit into is only 0.125” to 0.130” deep. This is why the sealant was so thick between the case halves. The ring prevents the halves from pulling tightly together.

Crankcase Groove depth 0.127 at this location.
Range 0.125" to 0.130"

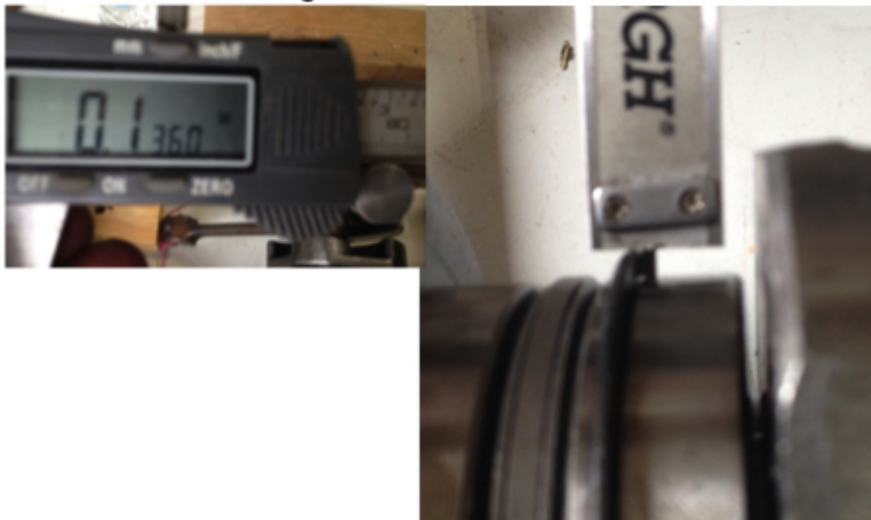
Bearing ring height 0.136 at this location.
Range 0.130" to 0.137"
