Personal Watercraft

Bulletin Number: **PWC-02-04 (A)**
Model Years: **2002**

SUBJECT: FUEL TANK INSPECTION / REPLACEMENT

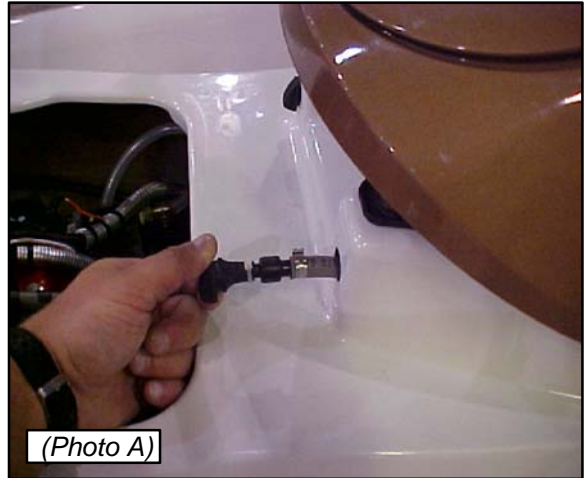
(Photo A)

1. Remove the seat and locate the fuel tank vent. Carefully pull the vent assembly through the top deck. *(Photo A)*
2. Remove the Oetiker™ clamp using a Oetiker™ clamp tool or side-cutting pliers. Discard clamp. Remove vent nipple from vent hose.

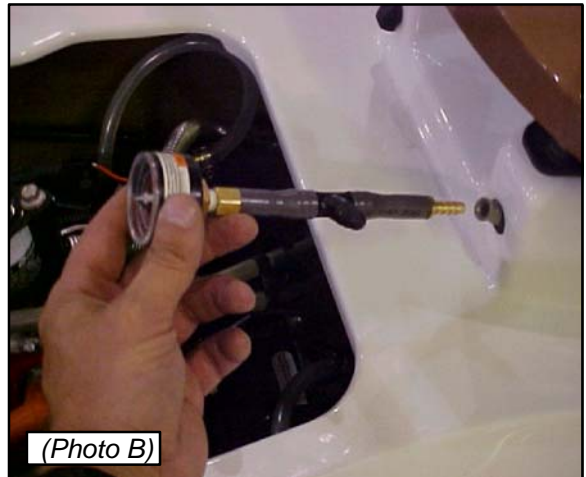
(Photo B)

3. Insert pressurization tool into vent line. *(Photo B)* Attach pump to Schrader™ valve. Tighten fuel cap. Pressurize fuel tank to 6 psi. (41 kPa)
4. With the fuel tank pressurized, monitor the air pressure gauge for at least 30 seconds. During the test, pressure should remain between 4 and 6 psi.
